Quarrying & Mineral  
Processing

Granite

K-ALOX/K-BAS

## K-ALOX & K-BAS Lined Hoppers & Transfer Chutes

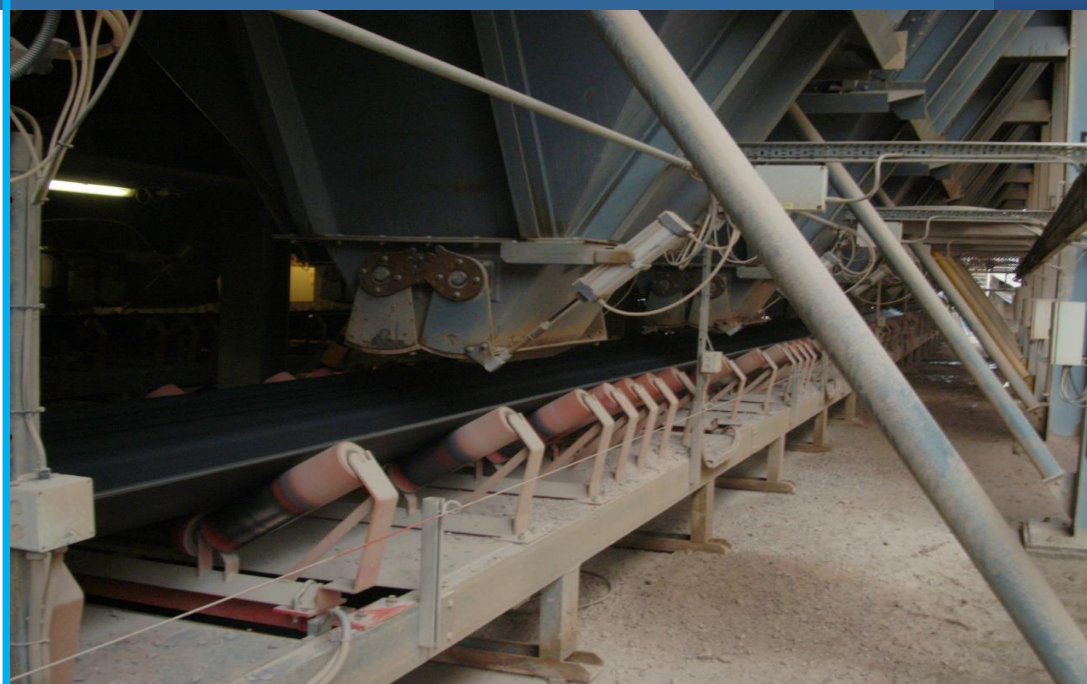
**Solution:** The top section of the sloping walls of the storage hoppers were subject to sliding abrasion, but the bottom sloping walls and discharge sections suffer from both sliding and impact induced abrasion. The combination that we chose had proven itself over long periods in very demanding applications. It comprised of our 40mm thick K-BAS, cast basalt lining, for the top sloping section of the hopper sides, and our 50mm thick 92P K-ALOX ceramic liners on the high wear areas in the bottom sloping and discharge chute sections. The K-BAS fused basalt lining is designed for conveying and storage systems that require high resistance to friction induced abrasion. The material has an extremely hard and smooth surface, which offers the added advantage of improving material flow. The 92P K-ALOX liner used in the discharge section is in the form of high alumina ceramic tiles. These are easy to shape and fit, and have a smooth low-friction surface that progressively polishes during use, preventing material build-up and improving material flow.

**Problem:** The granite handled at Mountsorrel is among the hardest known. Unfortunately, this fact was being brought home by the excessive levels of wear that were being experienced in the storage hoppers and conveyor transfer points at the railhead. The existing steel and rubber liners used within the system were not lasting six-months, due to the high levels of impact and sliding induced abrasion from handling the granite. This was resulting in high maintenance and repair costs, as infrastructure needed replacing frequently.
