Industry:
Mineral Processing
Plant:
Rotary Calciner
Lining System:
K-BAS lining system

K-BAS LINED ROTARY CALCINER

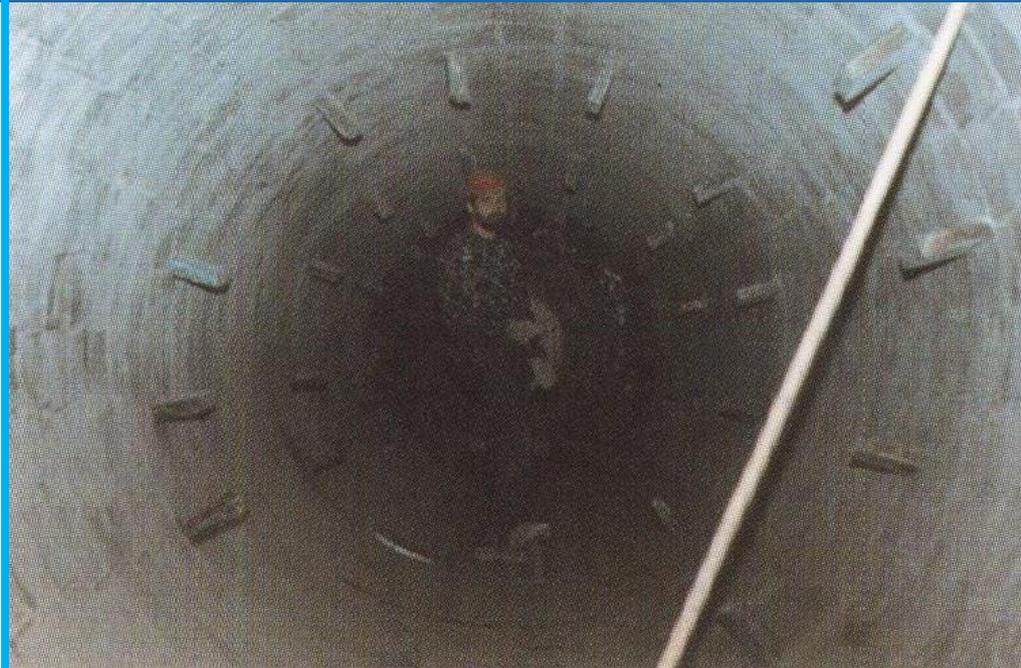
Problem: A UK manufacturer of Sodium Bicarbonate and Calcium Chloride was suffering from various problems within the calciner used to process the raw materials. The problems experienced were excessive wear due to the rotating motion of the conditioner and the abrasiveness of the products conveyed, the amount of chemical degradation on the existing rubber and chemical resistance linings due to concentration levels of sulphuric acid and finally continual product build up due to the high moisture content of the raw materials binding to the rough surface of the existing linings.

Solution: Following similar success within the chemical industry, Kingfisher's engineers recommended replacing the existing system with their very own K-BAS ceramic lining system which would eliminate the problems the customer was suffering from. This led to a turnkey project to remove the existing lining, shot blast the steel substrate, apply a chemical resistance membrane and then install our 30mm thick K-BAS ceramic lining system being fully bedded and jointed using a furane based adhesive system.

Benefit: The calciner now operates over a 12 month cycle where the need to shut the plant down for unscheduled repair and clean down of the calciner is non-existent.
