Drying Cyclone

K-ALOX Ceramic lining

K-ALOX LINED DRYING CYCLONE

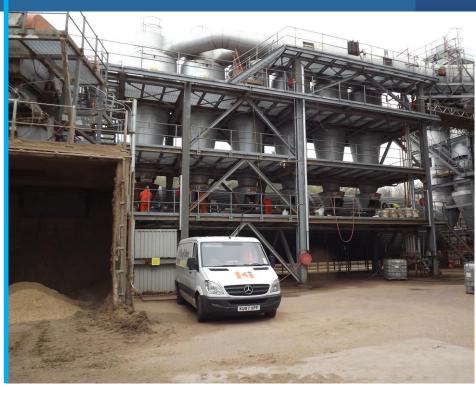
Problem: Due to the dependency on a greater volume of recycled wood within the manufacture of particle board, one international producer of these products was experiencing daily failures throughout its process plant. One problem of great concern was the structural integrity of the

drying cyclones situated after the drying drum operating in a positive phase of conveyance. The structure albeit made from Hardox wear plate had suffered from extreme abrasion due to amount of contamination in the wood stream.

Solution: Due to length of the Hardox system being in service, 2 year before failures, as the end user was reluctant to invest in the replacement of the cyclones, we decided to use our 92P K-ALOX ceramic lining solution that offers a far superior wear resistance and outperformed all abrasion resistant wear plates. Over a period of 6 months our operatives attended site every 2 months for a 24 hour period and totally covered the internal substrate with the ceramic lining system without the need for mechanical replacement activities, hence the customer was able to reutilise the cyclones without having to incur significant replacement costs.

Benefits: This system has lasted in excess of 8 years and albeit minor repairs have taken place due to mechanical damage, it is performing better than expected and its life expectancy based on the amount of wear experienced to date is in excess of 15 years. Factoring in all of the costs associated to the replacement, the system paid for itself in less than 2 years, achieving a trouble free service.
