Hi Kingfisher

Glass Bottle Manufacturing

K-ZAS & K-BAS lining system

K-ZAS & K-BAS LINED PIPEWORK

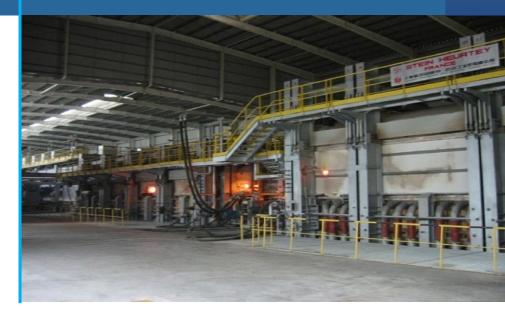
Handling raw cullet is a very abrasive process for many glass bottle manufacturers, as the process begins by melting glass in a furnace which melts cullet (crushed, recycled glass), sand, soda ash, limestone, and other raw materials, during this process pipework used to convey raw material to the furnace is subject to high levels of wear and abrasion, eventually causing the structural shell of the pipe to deteriorate and perforate.

Many manufacturers are having to replace pipework every 6months or less, resulting in thousands in maintenance costs. Following on from a site visit for a well-known glass bottle manufacturer, Kingfisher's engineers recommended a trial is carried out on the pipework which would be lined with a combination of K-BAS and K-ZAS ceramic lining systems, so the end user could compare the performance of a lined pipe VS un-protected pipe.

After comparing thickness test's on both sets of pipework after 4 weeks of production, it was clear the wear protected pipe had superseded the performance of the unlined pipe. Kingfisher were awarded the manufacture and installation of line one pipework, followed by a similar project carried out on the same plant for line 2, however due to the increased temperatures, it was recommended these pipes were installed with our 92p high alumina K-ALOX ceramic lining system.
